# Volunteer Summer Study

# 2023 Volunteer Summer Study

## INTRODUCTION

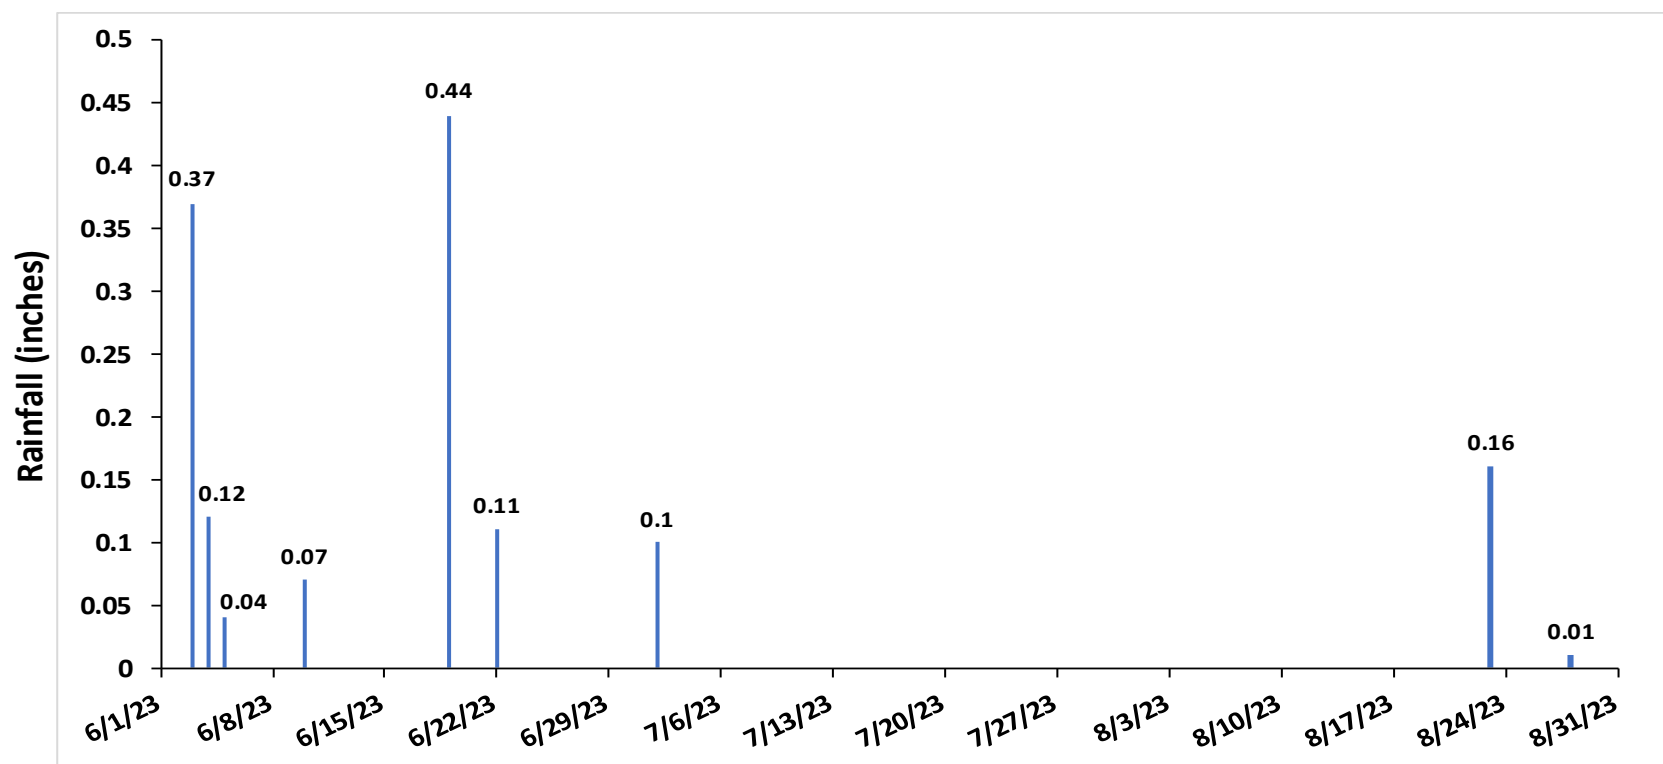
RAINFALL TOTALS 06/01/2023 – 08/31/2023

From June 1<sup>st</sup> – August 31<sup>st</sup> only 1.42 inches of rainfall was recorded by the Knipling-Bushland U.S. Livestock Insects Research Laboratory in Kerrville. This is a 67% decrease from the same period in 2022 (4.3 inches) which followed a 55% decrease from 2021 to 2022. The 30-year average for this timeframe is 7.3 inches.

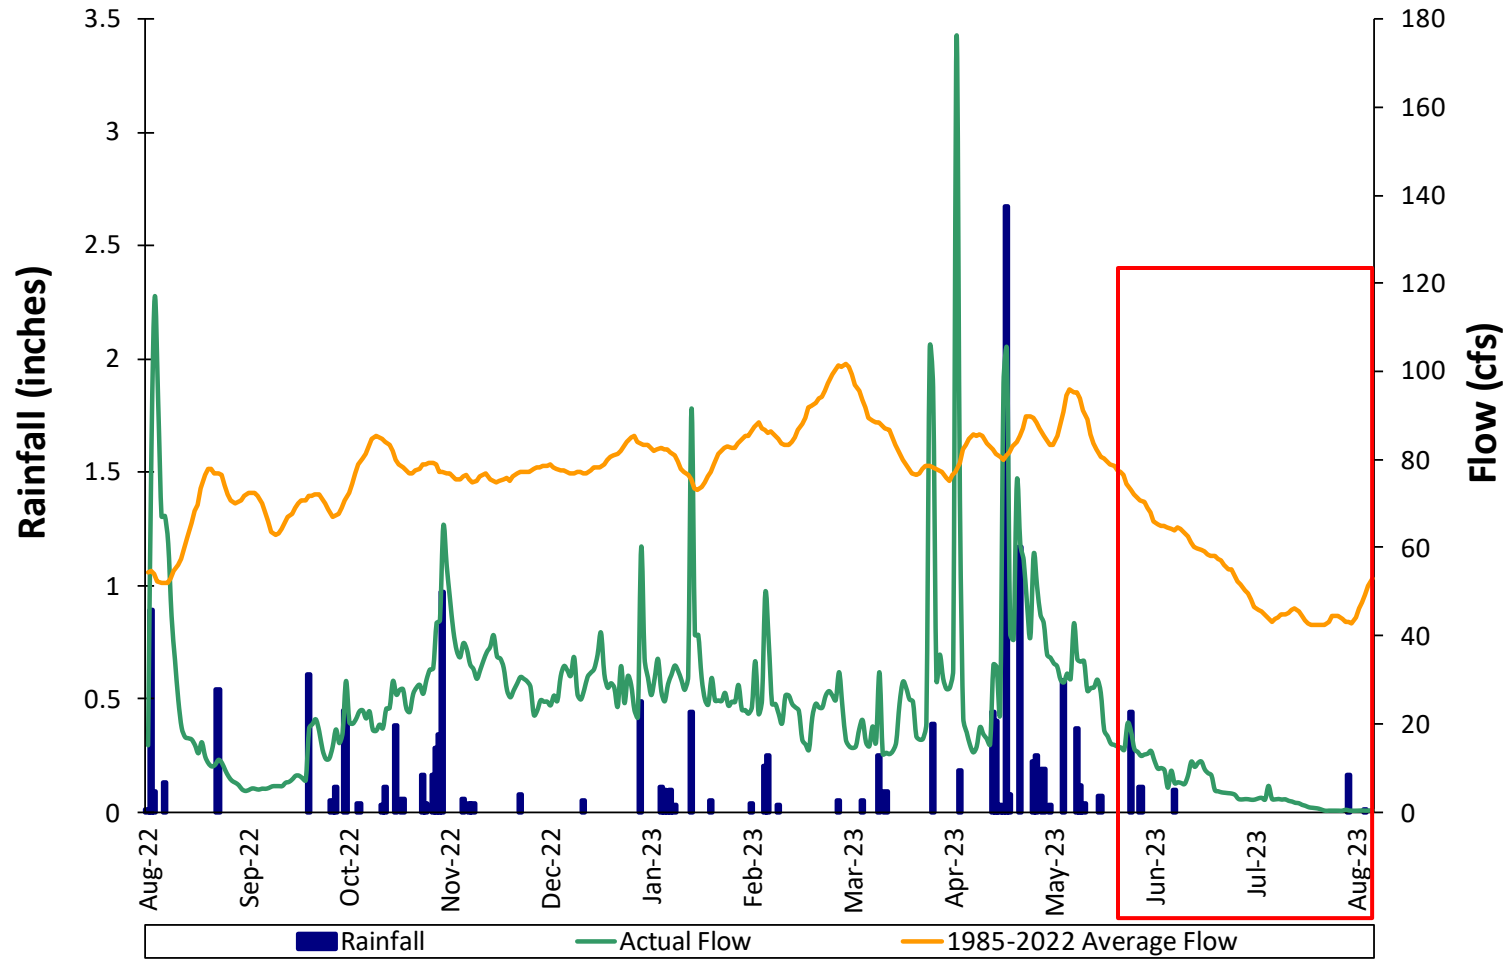
### RAINFALL vs FLOW

Nearly nonexistent rainfall caused already low streamflow to decrease to virtually 0 cubic feet per second during the volunteer monitoring period (outlined in red).

During the summer 2023 volunteer monitoring period, streamflow rates in the Guadalupe River were well below average as recorded by the U.S. Geological Survey streamflow gage in Kerrville (see page 6). Below average rainfall in 2022 was compounded in 2023 and the drought conditions continued to intensify. A brief respite was seen in May 2023 which brought above average rainfall (6.08 inches), as recorded by the Knippling-Bushland U.S. Livestock Insects Research Laboratory in Kerrville, however, all other months in 2023 received below average rainfall (see page 7). According to the U.S. Drought Monitor, Kerr County was in drought throughout the entire volunteer monitoring period (see pages 7-9). Sites along Town Creek and even the main stem of the Guadalupe River went dry during the volunteer monitoring period. However, the sites were included in this report to reflect the severity of the drought and its impact on water quality.

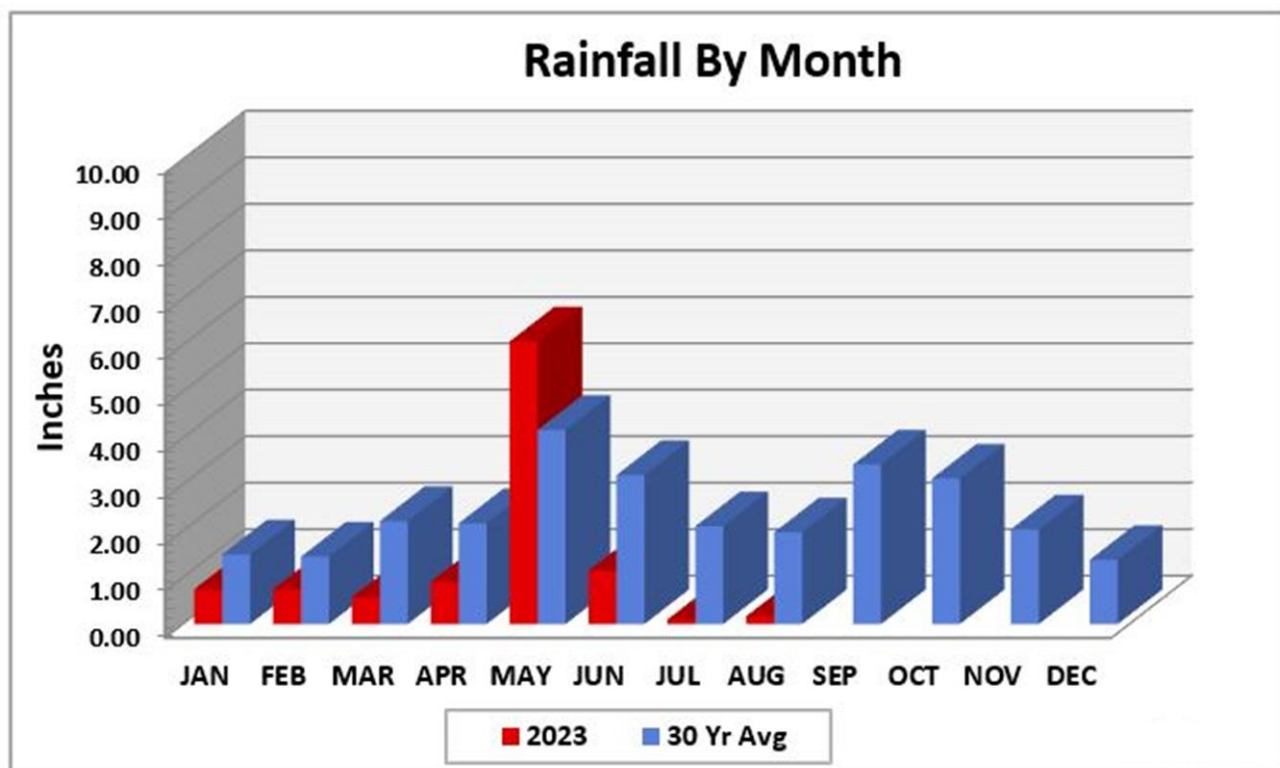
The long term trend of below average rainfall began in November 2021 and has continued through 2023 with the exceptions of August and November 2022 and May 2023. Since the 2022 volunteer monitoring period, drought conditions have intensified in Kerr County. Throughout the 2023 volunteer monitoring period, Kerr County remained in D2 (Severe Drought), D3 (Extreme Drought), or D4 (Exceptional Drought) drought classification.

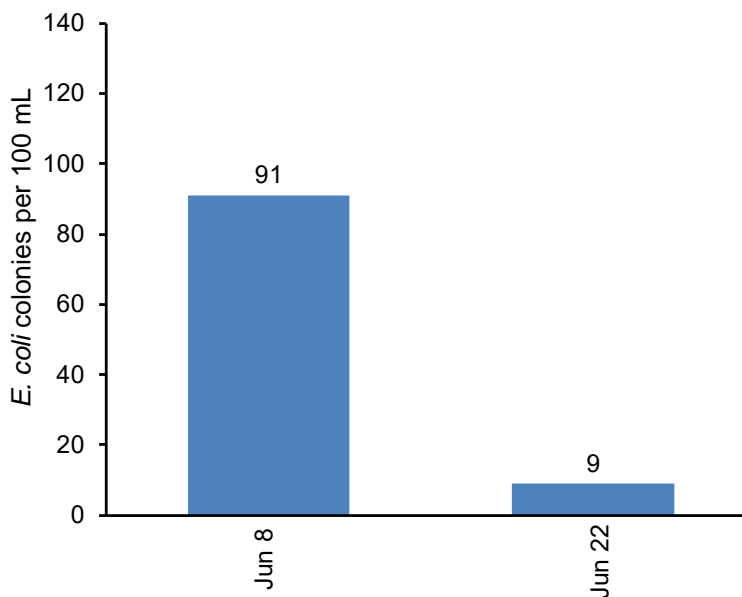
### \*Guadalupe at Ingram Park

\* Insufficient samples to calculate geometric mean.

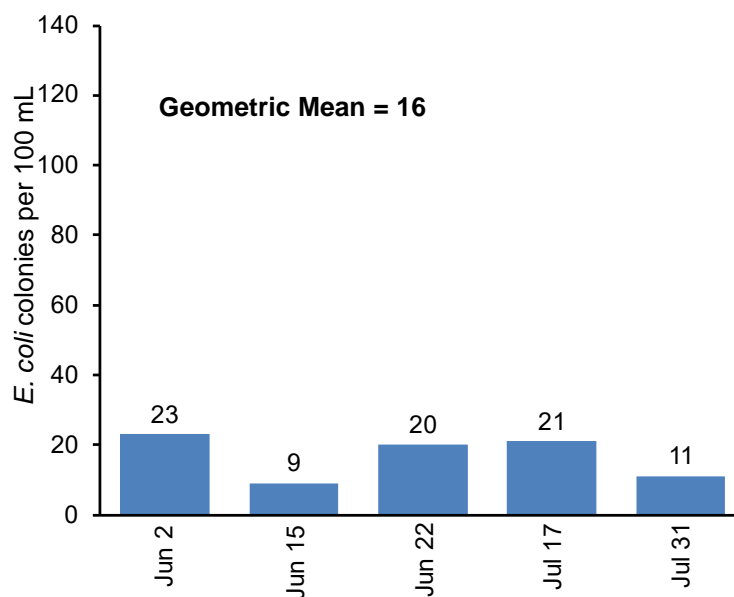
### \*Town Creek at Town Creek Rd.

\* Site went dry soon after sample minimum was met.

Town Creek had four sites where samples were taken this year. All of them went dry during the monitoring period and only one (Town Creek at Town Creek Rd.) had a sufficient sample size to calculate a geometric mean which was below 126 colonies per 100 mL. Of the remaining three sites (Town Creek at Morris Rd., Town Creek at Guadalupe Cemetery, Town Creek at Schreiner St.), two had individual samples above 399 colonies per 100 mL (Town Creek at Morris Rd., Town Creek at Guadalupe Cemetery). A noteworthy observation is that individual samples in two of these locations taken on July 6<sup>th</sup> show *E. coli* values below 399 colonies per 100 mL. It is hypothesized that the remaining small pools in these locations, before completely drying up, were exposed to extreme heat and ultraviolet radiation during late June and early July, possibly causing much of the *E. coli* to die off.

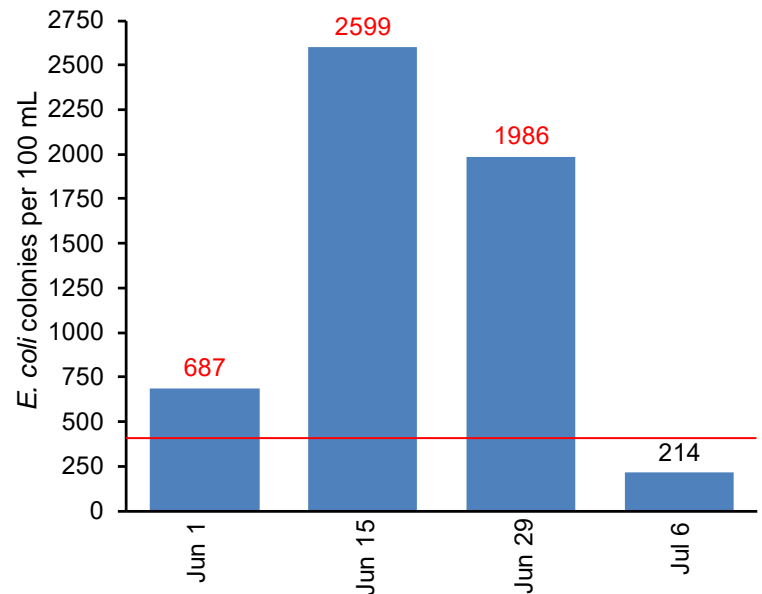
**\*Town Creek at Morris Rd.**

\* Insufficient samples to calculate geometric mean; volunteer's sample site went dry.

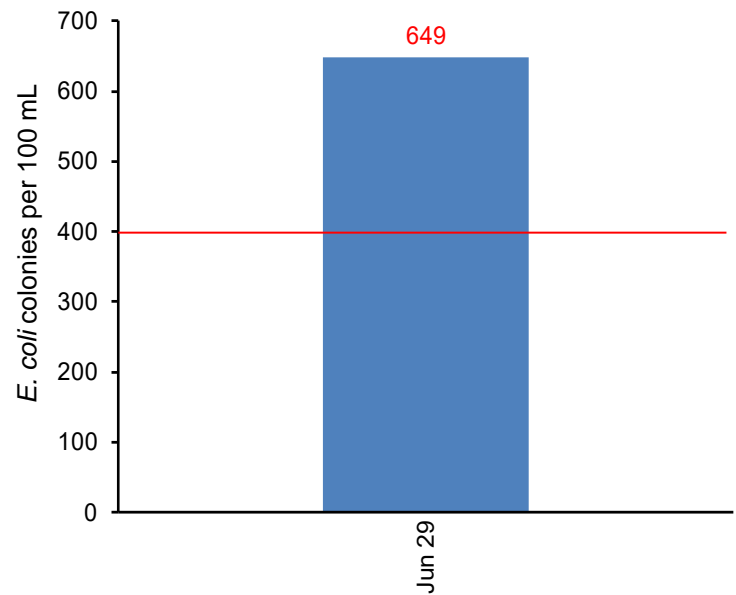
**\*Town Creek at Guadalupe Cemetery**

\* Insufficient samples to calculate geometric mean; volunteer's sample site went dry.

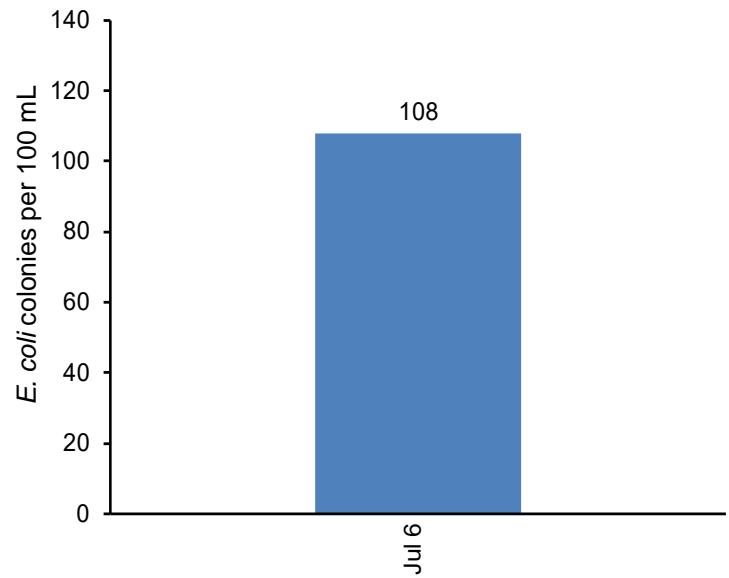
### \*Town Creek at Schreiner St.

\* Insufficient samples to calculate geometric mean; volunteer's sample site went dry.

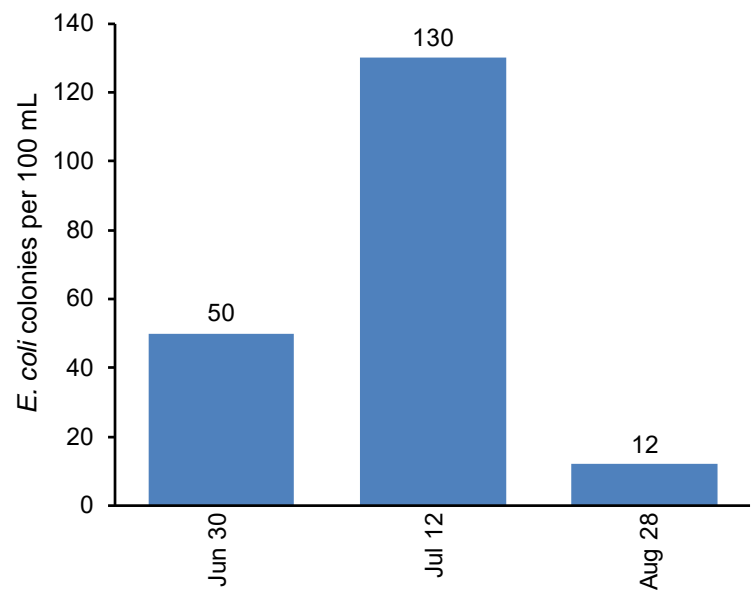
### \*Quinlan Creek at Habitat Park

\* Insufficient samples to calculate geometric mean.

During the 2022 volunteer sampling period, all three sample sites on Quinlan Creek had geometric means above 126 colonies per 100 mL. In 2023, the two sites on Quinlan Creek that were sampled had insufficient sample sizes to calculate a geometric mean, however, there were no individual samples above 399 colonies per 100 mL.

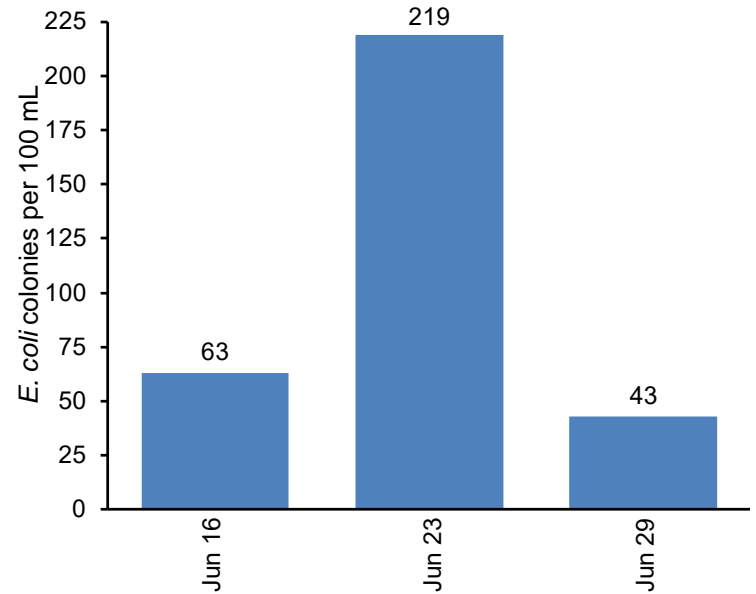
**\*Quinlan Creek at Hwy. 27**

\* Insufficient samples to calculate geometric mean.
