Clean Rivers Program
Basin Summary Report

Guadalupe River and
Lavaca-Guadalupe Coastal Basins

Guadalupe River Basin

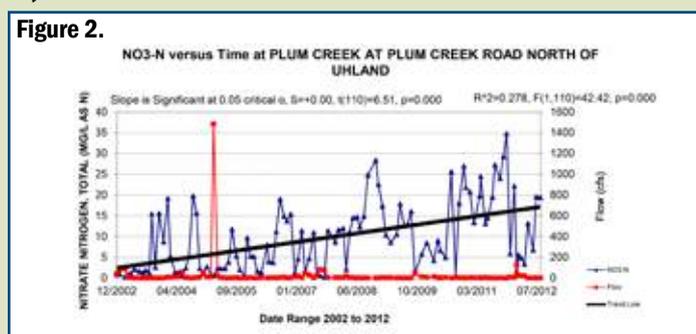
Nitrate nitrogen also shows an increasing trend over time (Figure 2). The median concentration for nitrate nitrogen was 8.24 mg/L, ranging from 0.22 mg/L to 34.8 mg/L, exceeding the screening concentration of 1.95 mg/L 75.9% of the time. Spikes in nitrate concentrations appear to be linked to low flow periods when the stream is effluent-dominated. Total phosphorus and nitrate nitrogen are of concern because of the potential for promoting nuisance algal blooms that can deplete oxygen in the stream, especially in the early morning hours, degrading the habitat for fish and aquatic invertebrates.

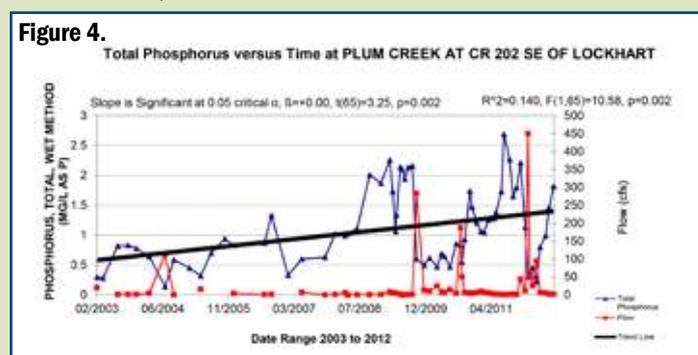
Figure 4 shows that **total phosphorus** concentrations are increasing over time at this monitoring station. Sources of total phosphorus include wastewater effluent, storm water that carries in fertilizers and organic material and failing septic tanks.

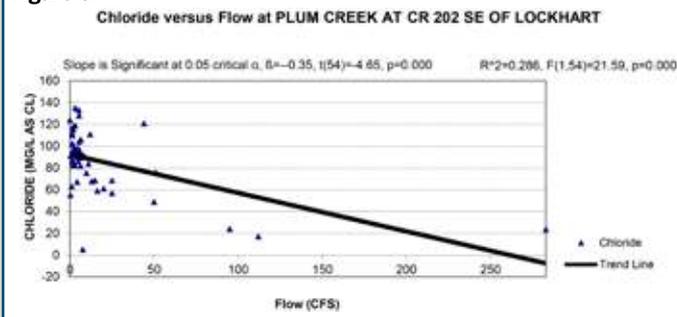
Figure 5.

trend over time. Another source of dissolved solids occurs when there are spills or leaks associated with oil field activities.

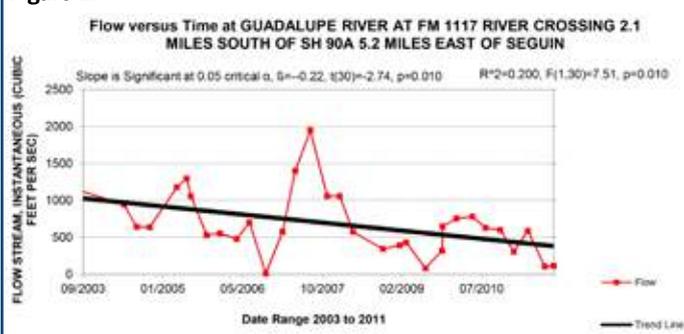
Figure 2.

been significantly decreasing (Figure 2) due to sustained drought conditions as seen at the FM 1117 monitoring station. The reductions in flow also affect other water quality parameters such as pH which is significantly rising throughout this portion of the Guadalupe River. As more photosynthesis occurs in slower moving river systems, carbonic acid is removed from the water column, which increases pH levels (Figure 3).

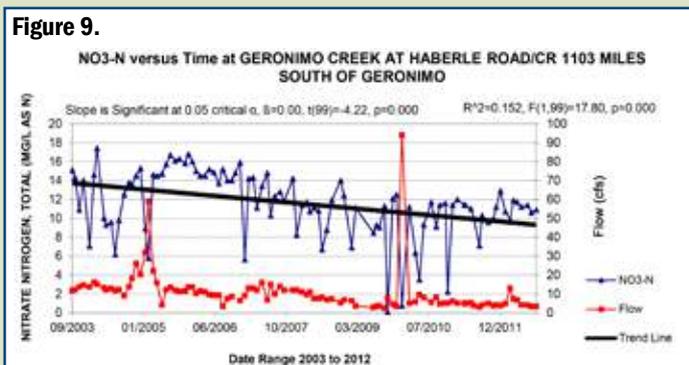
Figure 9.

basin present an interesting question about the source of this contamination. The GBRA and USGS will be conducting a nitrogen isotope study beginning in 2014 will attempt to determine the source of nitrates in the Leona formation.
