Approved August 31, 2011

**Implementation Plan for
One Total Maximum Daily Load
for Bacteria in Guadalupe River
Above Canyon Lake
Segment 1806**

Water Quality Planning Division, Office of Water

TEXAS COMMISSION ON ENVIRONMENTAL QUALITY

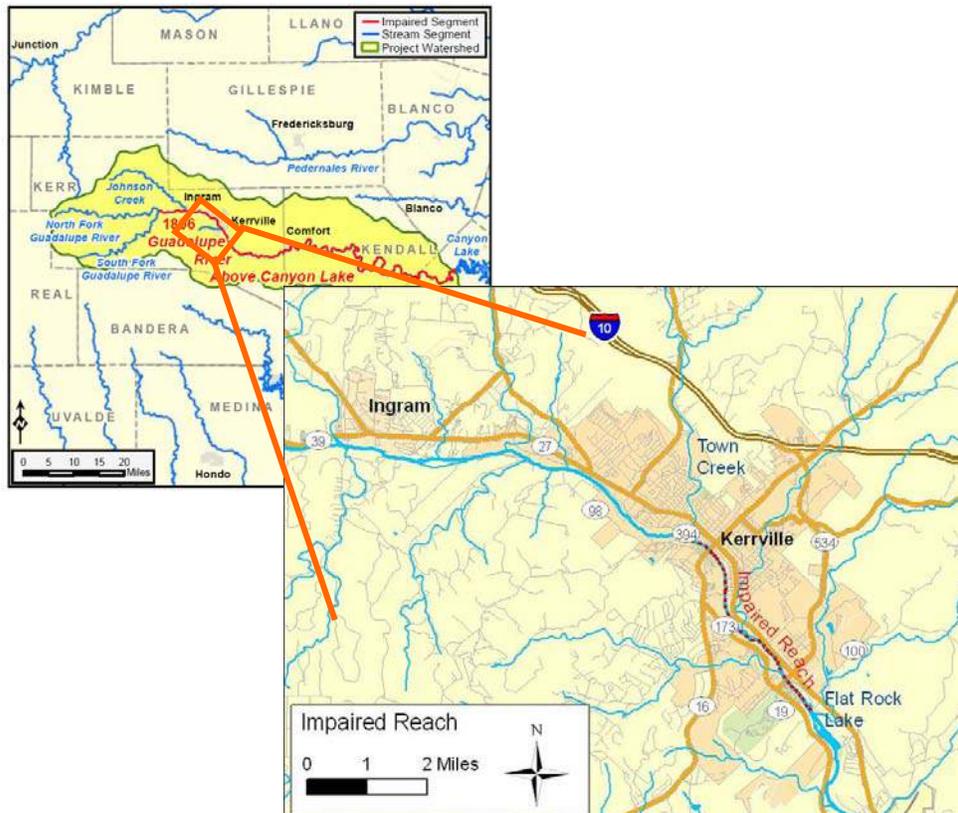
Figure 1: Map of the impaired reach of the Upper Guadalupe River Above Canyon Lake

In 2002, the Upper Guadalupe River was identified as impaired due to excessive levels of indicator bacteria (*E. coli*). The Guadalupe River Above Canyon Lake is identified as Segment 1806 by the TCEQ. The upstream end of this segment is the confluence of the North and South Forks of the Guadalupe River in Kerr County. The downstream end of this segment is Canyon Reservoir, which begins 1.7 miles downstream of Rebecca Creek Road in Comal County. This project includes only a small reach of Segment 1806, located within the City of Kerrville, which is impaired for contact recreation. The impaired reach is defined as the Guadalupe River from its confluence with Town Creek downstream to Flat Rock Lake, as illustrated in Figure 1. This implementation plan addresses the impaired AUs and the watershed of the main tributaries of those AUs.

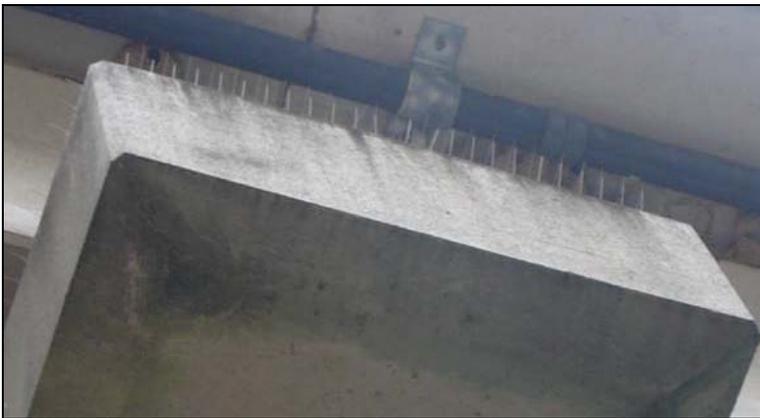
Figure 3: Pigeon Deterrents on Highway 16 Bridge

Several methods of pigeon control are available. Unlike most Texas birds, pigeons are a non-native species, and are not protected by any federal or state laws. Since the primary goal of this project is to prevent pigeons from resting on bridges over a water body or in shallow pools on the water's edge, exclusion is an effective option. Exclusion of pigeons from bridges will be accomplished using screens, wires, netting, and/or spikes. Spikes have already been employed as a pigeon deterrent on portions of the Highway 16 bridge at Louise Hays Park as shown in Figure 3.

Bird deterrent/exclusion structures consisting of spikes and netting will be installed on the underside of the bridge sections over the water on which a bird could roost or build a nest at the State Highway 16 and Loop 534 crossings. The bird deterrent/exclusion structures will be applied on a total of 39,606 square feet. The bird deterrent structures are estimated to last at least five years with little to no maintenance. UGRA staff will inspect structural BMPs periodically and apply for additional funding for maintenance and replacement if necessary. A traffic control plan will also be prepared by TxDOT to address traffic concerns during the installation of the deterrent/exclusion devices.
